SITE OBSERVATION REPORT – Remedial Investigation – Day 02

PROJECT No.: 170698601 CLIENT: DATE: Thursday, 10 November 2022

PROJECT: 125 3rd Street Third Street Gowanus Owner. WEATHER: Sunny, 48-63 °F Wind: SW @ 0-5 mph

LOCATION: Brooklyn, New York LLC TIME: 6:00 a.m. – 5:00 p.m.

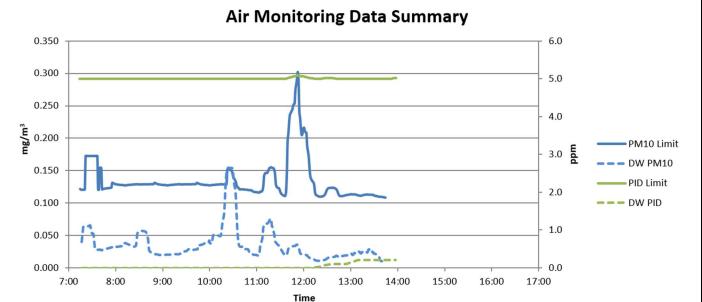
• Langan implemented the CAMP at upwind and downwind locations to monitor VOCs and particulate matter less than 10 microns in size (PM10) during ground-intrusive work. 15-minute-average concentrations of VOCs and PM10 were not recorded above the action levels during the monitoring period. No fugitive dust or odors associated with intrusive activities were observed migrating off site. Recorded air monitoring data is presented on the following graph:

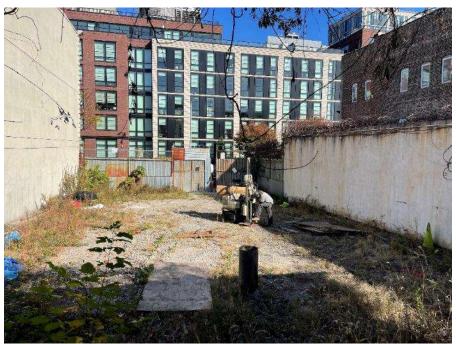
- o **SB11** was advanced to a depth of about 20 feet bgs. No visual, olfactory, or instrumental evidence of impacts was identified.
 - SB12 was advanced to a depth of about 16 feet bgs (confining layer encountered at about 14.5 feet bgs).
 No visual, olfactory, or instrumental evidence of impacts was identified.

Photo 1: Eastern advancing soil boring SB11 (facing northeast).

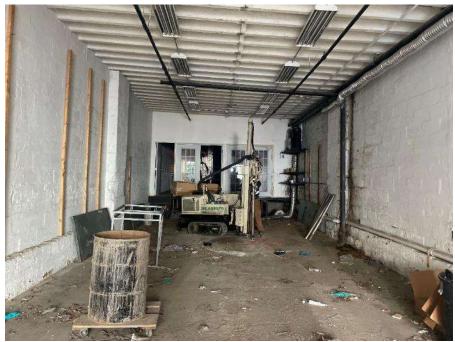
- o **SB17** was advanced to a depth of about 20 feet bgs. No visual, olfactory, or instrumental evidence of impacts was identified.
- Eastern installed one monitoring well at SB10 as follows:

Photo 2: Eastern advancing soil boring SB17 (facing southwest).
